**FineLine**  
- SNAGGING -

## Snag List Report

**Date of Inspection**  
01/08/2026

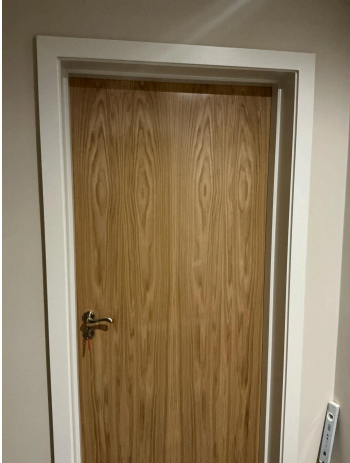
| 1 | | <ul style="list-style-type: none"><li>- Very warm in the front hallway, will ventilation be installed?</li></ul> |

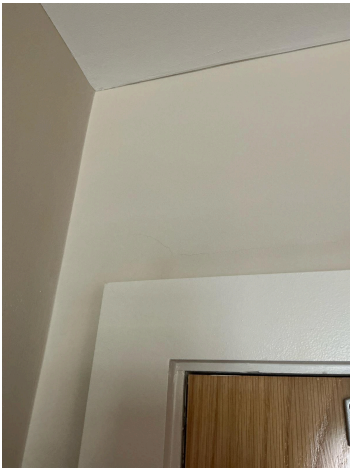
| 2 | | <ul style="list-style-type: none"><li>- Hairline crack above front door frame on left side</li></ul> |

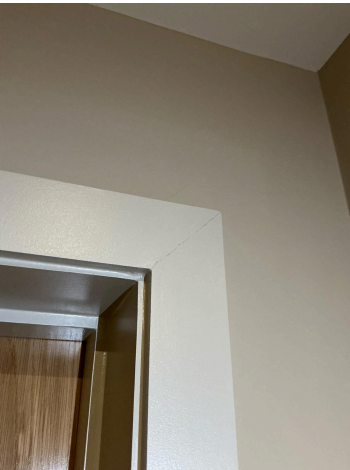
| 3 | | <ul style="list-style-type: none"><li>- Door frame cracked at joint of both top corners</li></ul> |

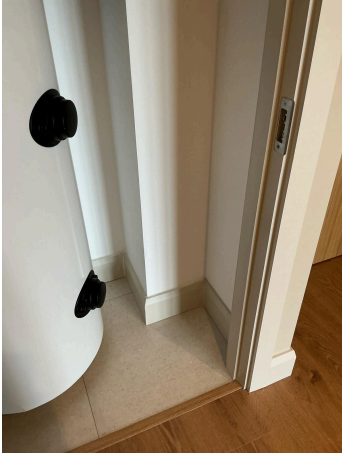
| 10 | | <ul style="list-style-type: none"><li>- Touch up skirting at bottom right of room</li><li>- Touch up paint halfway up the wall</li><li>- Seal door frame to wall on right side when walking in</li></ul> |

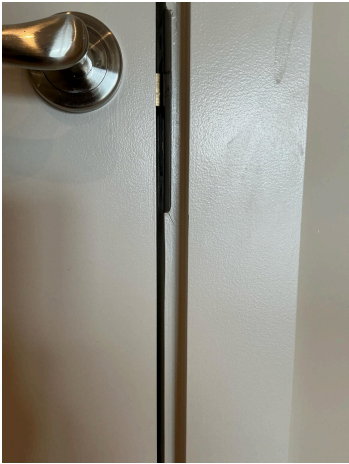
| 11 | | <ul style="list-style-type: none"><li>- Touch up minor cracks and marks to the right of the door receiver</li><li>- Remove paint from hinges on the outside of the door</li></ul> |

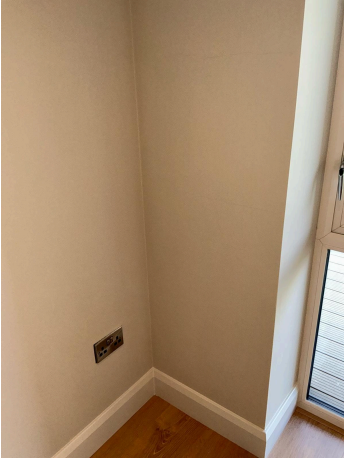
| 22 | | <ul style="list-style-type: none"> <li>- Multiple hairline cracks on the wall to the left of balcony door</li> <li>- Double socket covered in dust - clean all</li> </ul> |

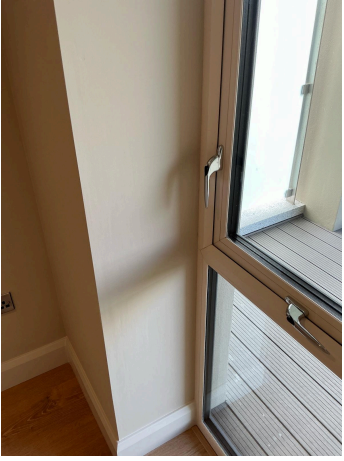
| 23 | | <ul style="list-style-type: none"> <li>- Rough finish to plaster next to the balcony window</li> <li>- Hairline crack next to window sash handle</li> </ul> |

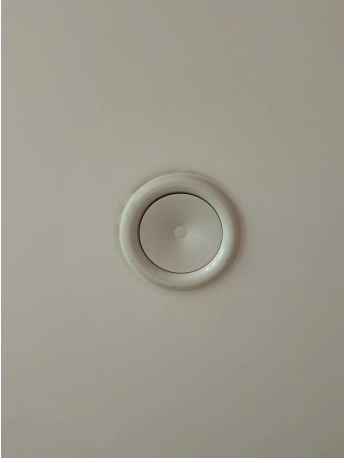
| 24 | | <ul style="list-style-type: none"> <li>- Vent marked and uncentered</li> </ul> |

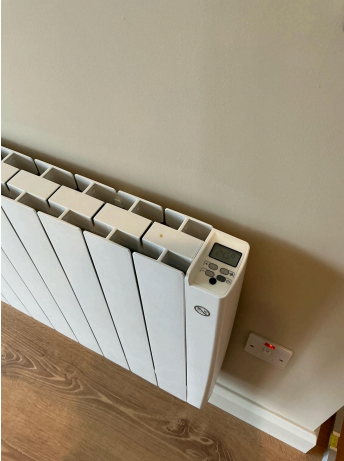
| 25 | | <ul style="list-style-type: none"> <li>- Radiator marked / dirty</li> <li>- Radiator operational and heating</li> </ul> |

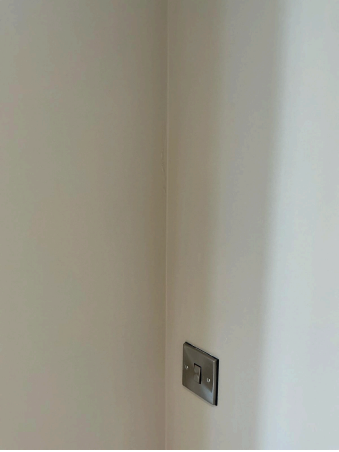
| 26 | | <ul style="list-style-type: none"> <li>- Remove paint marks from sockets and switches</li> <li>- Plaster cracking in right corner of the room running from halfway up to the ceiling</li> </ul> |

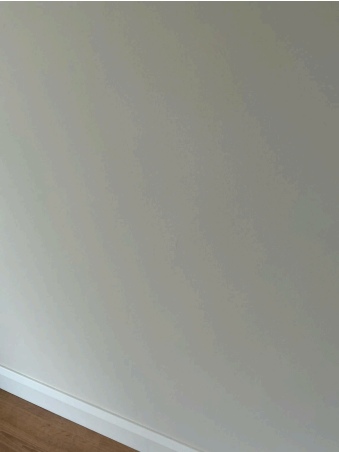
| 27 | | <ul style="list-style-type: none"> <li>- Wall marked / scratched in the middle of the right side wall</li> </ul> |

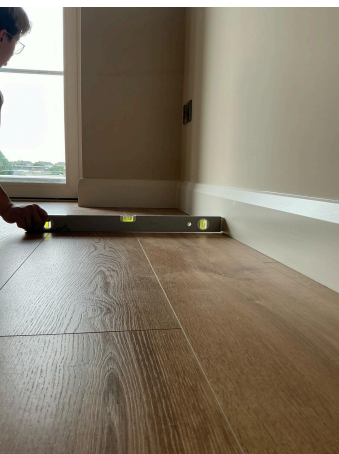
| Nr. | Location | Item | Why it's flagged |
|---|---|---|---|
| 28 | Living room | Floor level low at edge of right-hand wall | Structural / sub-floor - developer to confirm remedy |

| 28 | | <ul style="list-style-type: none"> <li>- <b>Priority</b></li> <li>- Floor level low at the edge of right side wall</li> <li>- Builder to confirm possible solutions with the client</li> </ul> |

- Floor level low at the edge of right side wall in *Living Room*
- Considerable level difference in floor at wardrobe entryway in *Master Bedroom*
- Considerable level difference in floor of bedroom to hallway entry at *Bedroom 2*

The builder is to confirm possible solutions and remedies with the client before final sign-off.

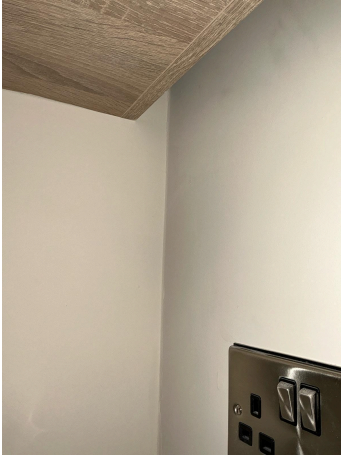
| 35 | | <ul style="list-style-type: none"> <li>- Reseal main corner of kitchen near top cabinets</li> </ul> |

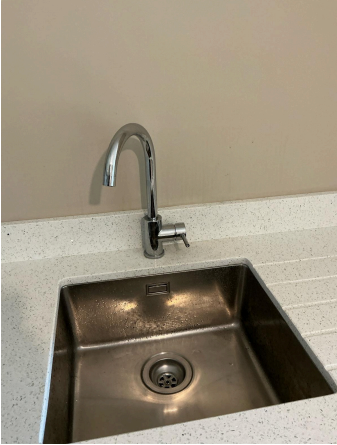
| 36 | | <ul style="list-style-type: none"> <li>- Remove splash marks from wall behind sink - touch up full wall</li> <li>- Sink working OK</li> <li>- Water pressure OK</li> <li>- Clean marks on sink tap</li> </ul> |

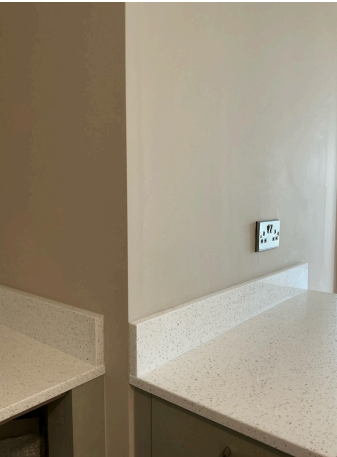
| 37 | | <ul style="list-style-type: none"> <li>- Rough finish to wall on left side of island - scratches, dents and paint drips</li> <li>- Wall cracked between the island and sink splashbacks</li> </ul> |

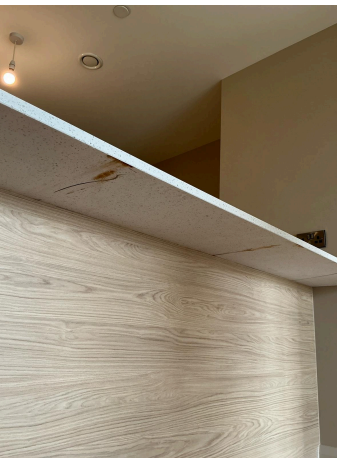
| 38 | | <ul style="list-style-type: none"> <li>- Under the marble top is considerably stained / rusted and marked.</li> <li>- Seal marble top to wooden panel</li> </ul> |

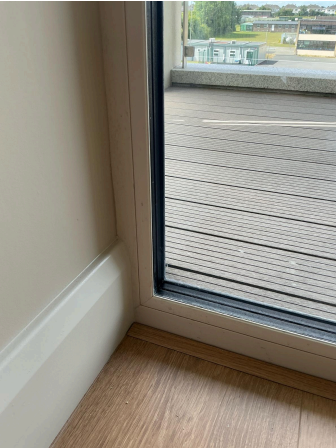
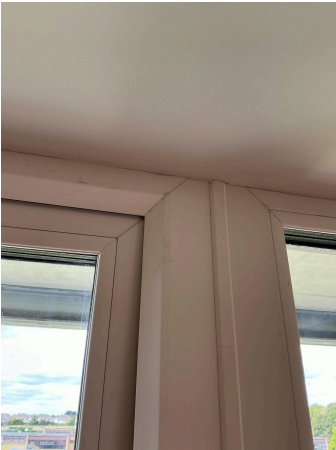
| <p>39</p> | <br> Two photographs showing close-up views of the balcony window frame. The top photo shows the frame from the side, highlighting the wooden deck and the white wall. The bottom photo shows the frame from the front, highlighting the glass and the white wall. | <p>- Whole interior frame is marked and dirty - clean and ensure no dents or scratches</p> |

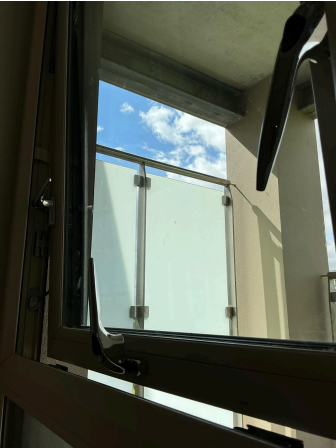
| <p>40</p> | A photograph showing a close-up view of the balcony window frame. The frame is dark-colored and the glass is clear. The view outside shows a blue sky with clouds. | <p>- Remove all residue and clean down glazing - ensure no scratches</p> |

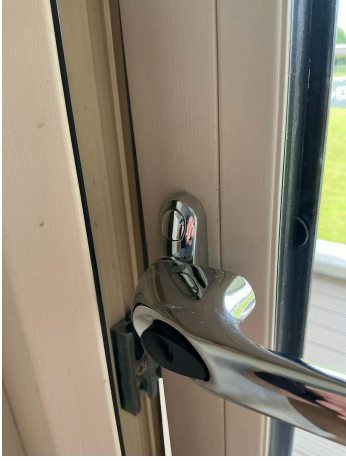
| Nr. | Location | Item | Why it's flagged |
|---|---|---|---|
| 41 | Balcony | Right-hand window handle loose, drops on its own | Functional / security - repair or replace |

| 41 | | <ul style="list-style-type: none"> <li>- <b>Priority</b></li> <li>- Right handle of window is loose and falls down on its own - repair or replace</li> <li>- Screw caps broken and damaged at window handles</li> <li>- Paint splashes on handles</li> </ul> |

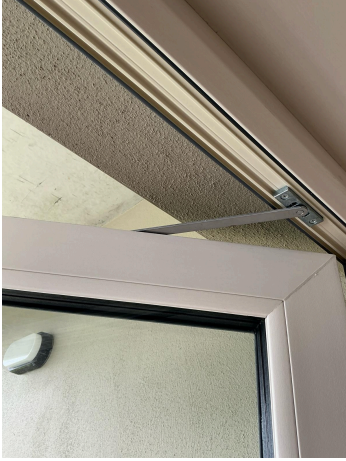
| 42 | | <ul style="list-style-type: none"> <li>- Door squeaking / rubbing off top closer</li> </ul> |

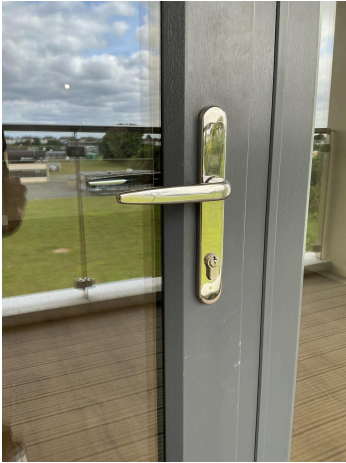
| 43 | | <ul style="list-style-type: none"> <li>- Exterior ironmongery scratched and marked</li> </ul> |

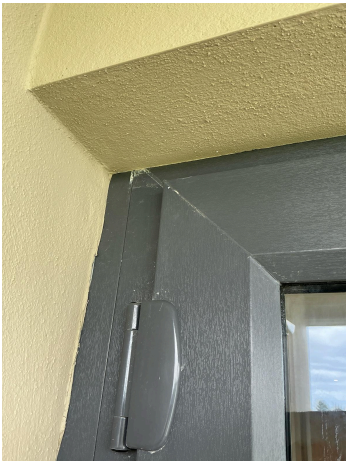
| 44 | | <ul style="list-style-type: none"> <li>- Full exterior frame marked with residue, paint, filler. Clean and ensure any hidden scratches are repaired</li> </ul> |

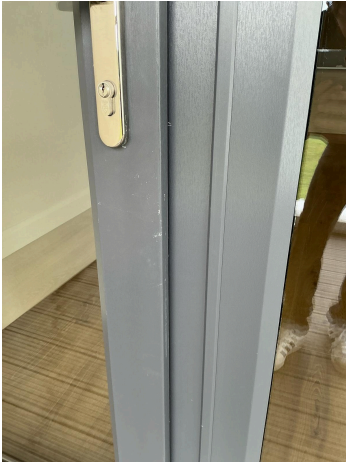
| | | <ul style="list-style-type: none"><li>- Full exterior frame marked with residue, paint, filler. Clean and ensure any hidden scratches are repaired</li></ul> |

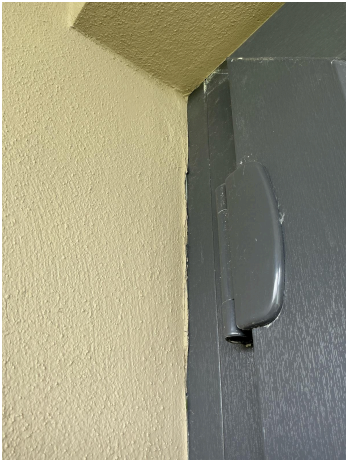
| 45 | | <ul style="list-style-type: none"><li>- Seal both sides of the frame to the wall</li></ul> |

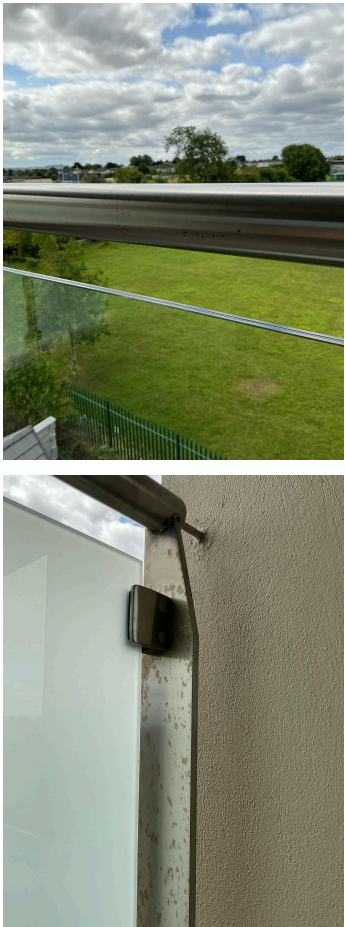
| 46 | | <ul style="list-style-type: none"><li>- All ironmongery considerably stained and rusted - clean as best as possible</li></ul> |

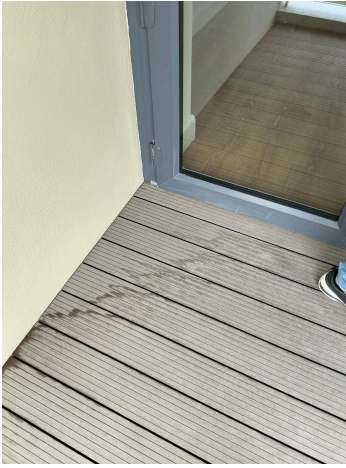
| 47 | | <ul style="list-style-type: none"> <li>- Squeaking floor boards outside balcony door - can this be reduced?</li> </ul> |

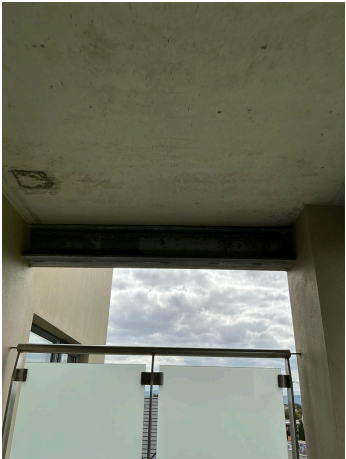
| Nr. | Location | Item | Why it's flagged |
|---|---|---|---|
| 48 | Balcony | Steel beam / floor above appears uneven - gap inconsistent side to side | Structural - recommend engineer review |

| 48 | | <ul style="list-style-type: none"> <li>- <b>Priority</b></li> <li>- Steel beam or floor above seems to not be level as gap between them is small on left side and large on the right</li> <li>- Remove debris and concrete snots from ceiling and steel beams</li> </ul> |

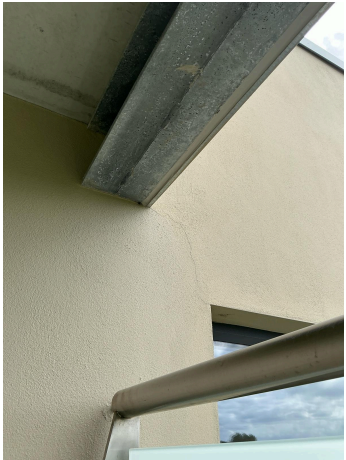
| Nr. | Location | Item | Why it's flagged |
|---|---|---|---|
| 49 | Balcony | Wall cracked under steel beam above bedroom window | Structural - recommend engineer review |

| 49 | | <ul style="list-style-type: none"> <li>- <b>Priority</b></li> <li>- Wall cracked under steel beam above bedroom window</li> </ul> |

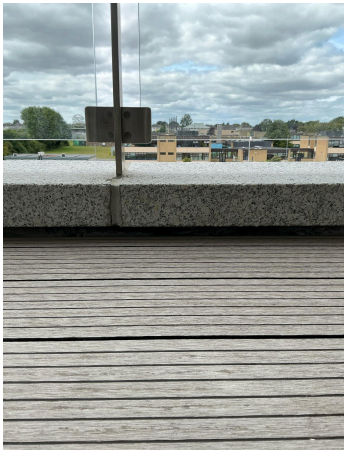
| 50 | | <ul style="list-style-type: none"> <li>- Uneven / unfinished concrete work under balcony sill on the right side</li> </ul> |

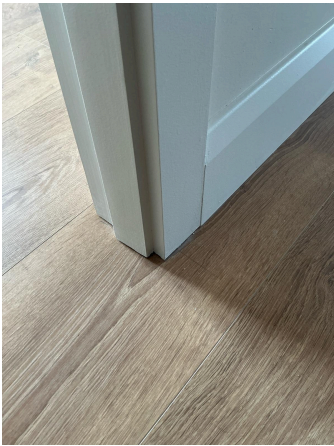
| 52 | | <ul style="list-style-type: none"><li>- Remove pencil marks from floor - check all</li></ul> |

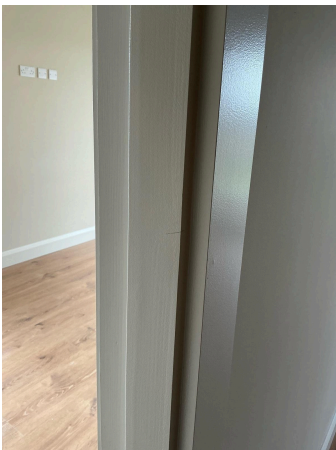
| 53 | | <ul style="list-style-type: none"><li>- Minor crack in frame above receiver</li></ul> |

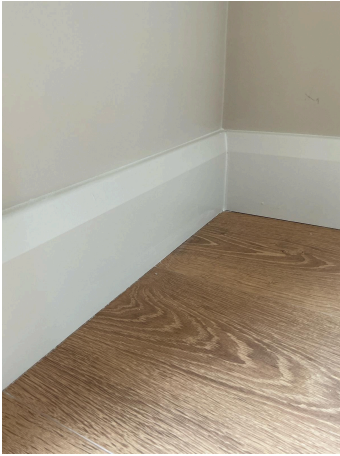
| 54 | | <ul style="list-style-type: none"> <li>- Touch up skirting near right side internal corner of room - discoloured / marked</li> </ul> |

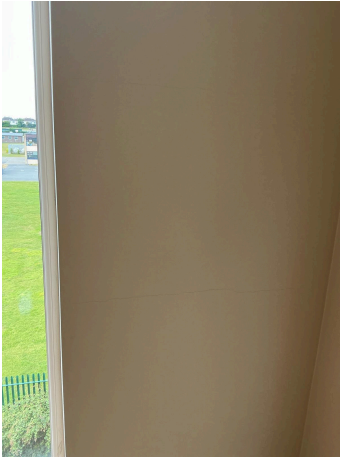
| 55 | | <ul style="list-style-type: none"> <li>- Hairline cracks throughout the left side wall of the right side internal corner of the room.</li> <li>- Smooth out finish and touch up paint towards top of same</li> </ul> |

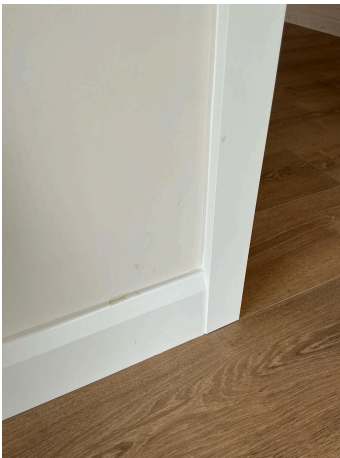
| 56 | | <ul style="list-style-type: none"> <li>- Skirting and frame stained to left of door</li> </ul> |

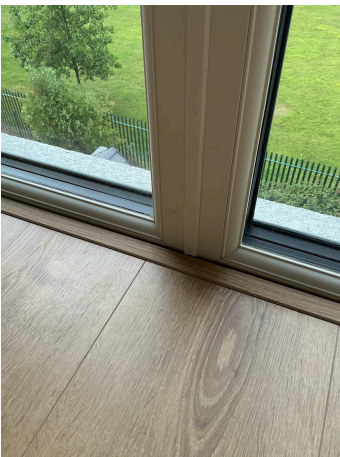
| 57 | | <ul style="list-style-type: none"> <li>- Transition bar at window not glued to floor</li> <li>- Window frame has damage and marks - check full frame and repair</li> </ul> |

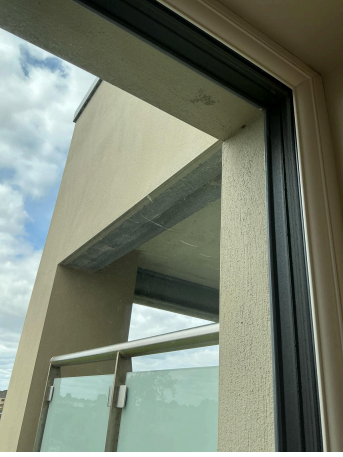
| 58 | | <ul style="list-style-type: none"> <li>- Possible glazing scratch on right side near the top of the window - confirm it is not scratched</li> </ul> |

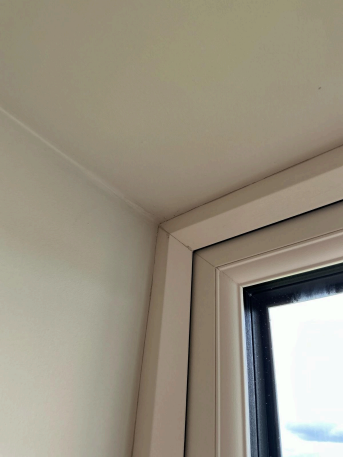
| 59 | | <ul style="list-style-type: none"> <li>- Seal window frame to reveals all around</li> </ul> |

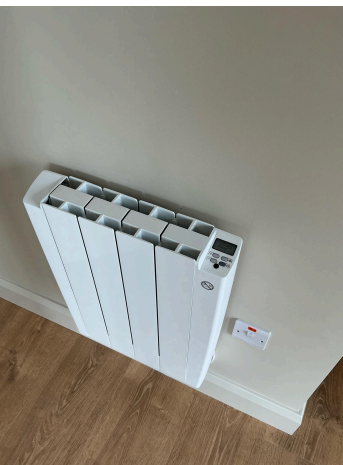
| 61 | | <ul style="list-style-type: none"> <li>- Radiator operational and heating</li> <li>- Minor pencil marks behind radiator to be touched up</li> <li>- Scratch in wall 400mm above radiator and to the right</li> </ul> |

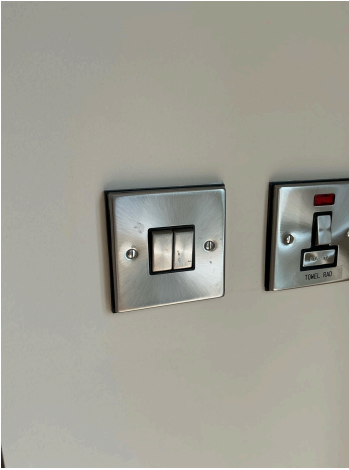
| 62 | | <ul style="list-style-type: none"> <li>- Light switch marked</li> </ul> |

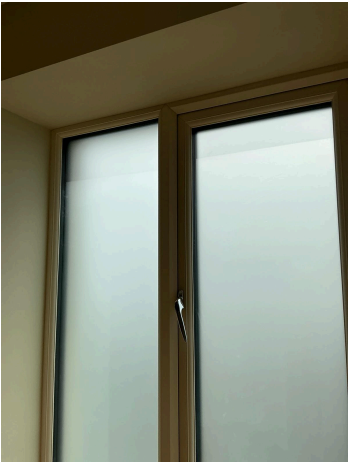
| 63 | | <ul style="list-style-type: none"> <li>- Frosted window frame has damage on right side</li> <li>- Seal around frame to reveals</li> </ul> |

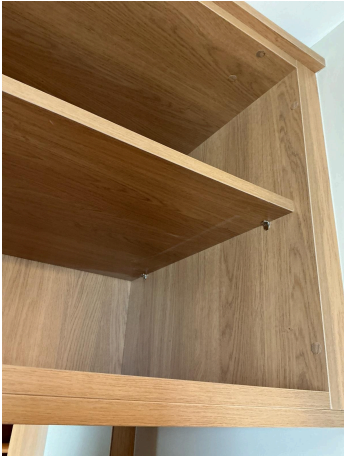
| 68 | | <ul style="list-style-type: none"> <li>- Clean down all compartments and hanger rails</li> <li>- Remove sticker from back of panel to left side of en-suite door</li> </ul> |

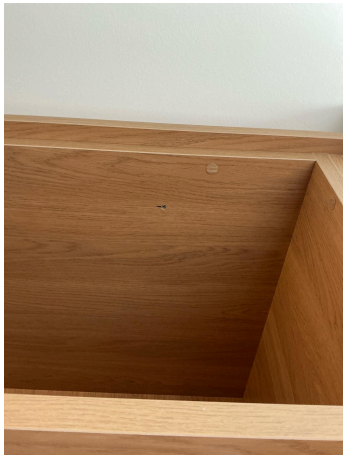
| 69 | | <ul style="list-style-type: none"> <li>- Screw cover missing in the section opposite to the mirror, check all throughout wardrobe</li> </ul> |

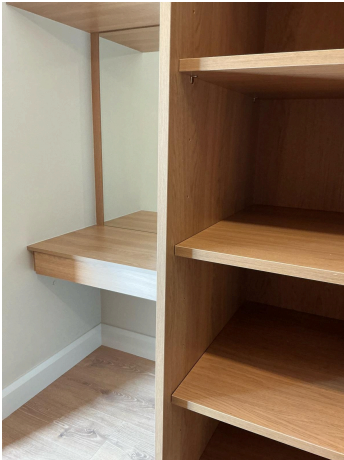
| 70 | | <ul style="list-style-type: none"> <li>- Tighten the left panel inwards on the small compartment section</li> </ul> |

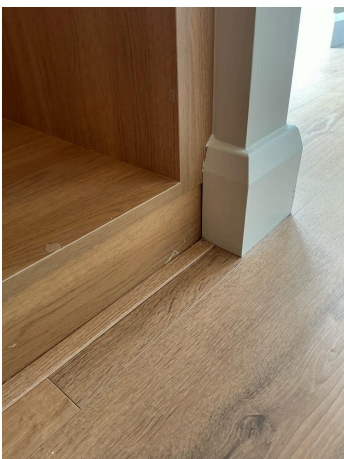
| 71 | | <ul style="list-style-type: none"> <li>- Seal skirting to wardrobe panel</li> <li>- Bottom kick board damaged</li> <li>- Transition bar corner damaged where two joining</li> </ul> |

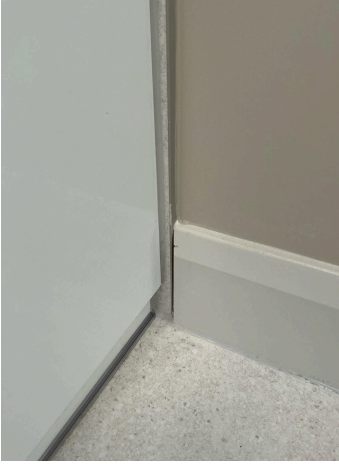
| 75 | | <ul style="list-style-type: none"> <li>- Seal skirting to edge of the bath</li> </ul> |

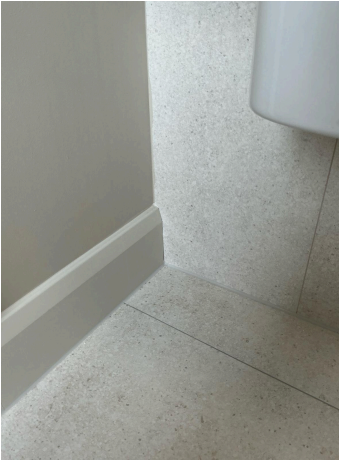
| 76 | | <ul style="list-style-type: none"> <li>- Seal skirting at left side under WHB</li> </ul> |

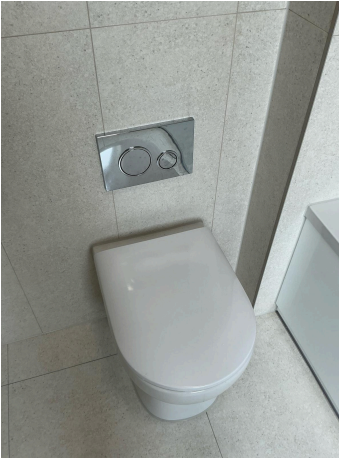
| 77 | | <ul style="list-style-type: none"> <li>- Flush panel inaccessible while toilet seat is up</li> <li>- Toilet bowl marked and stained - clean and sanitize all sanitary ware</li> <li>- Flush panel is loose on wall</li> </ul> |

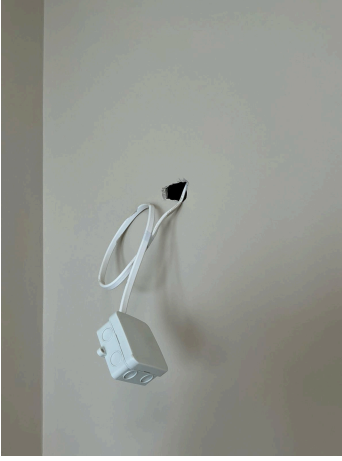
| 78 | | <ul style="list-style-type: none"> <li>- Fix socket to wall and / or repair hole around cable</li> </ul> |

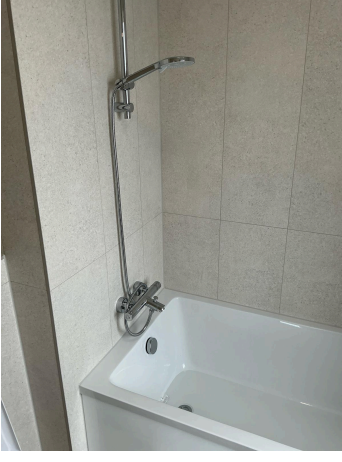
| 79 | | <ul style="list-style-type: none"> <li>- Bath stopper stuck</li> <li>- Water pressure OK</li> <li>- Tap working OK</li> <li>- Shower working OK</li> <li>- Clean down temperature / pressure controls</li> </ul> |

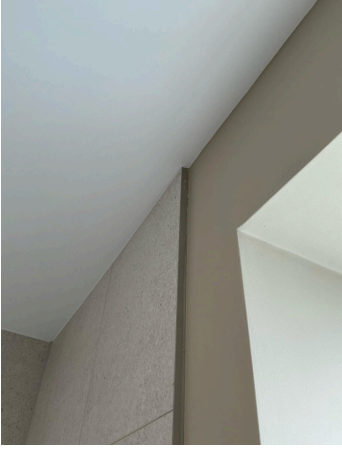
| 80 | | <ul style="list-style-type: none"> <li>- Clean down full tile trim</li> </ul> |

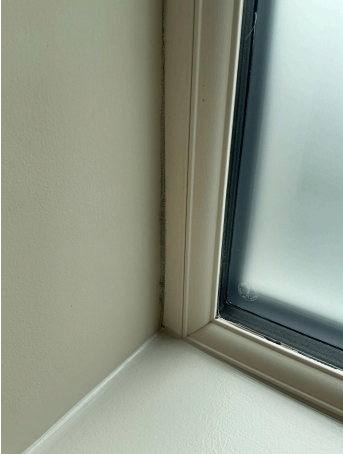
| 81 | | <ul style="list-style-type: none"> <li>- Remove residue from edge of window frame</li> <li>- Seal frame to window reveals</li> </ul> |

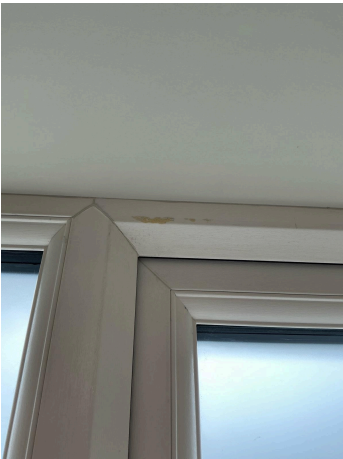
| 82 | | <ul style="list-style-type: none"> <li>- Frame marked and damaged, repair and clean full frame</li> </ul> |

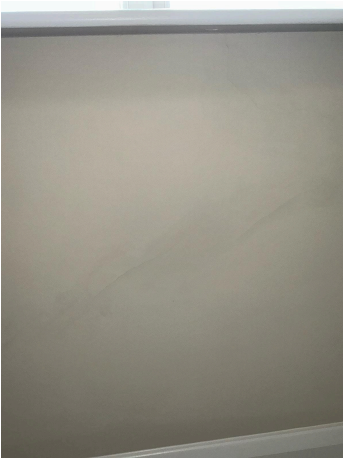
| 83 | | <ul style="list-style-type: none"> <li>- Large crack running down from window board to skirting</li> </ul> |

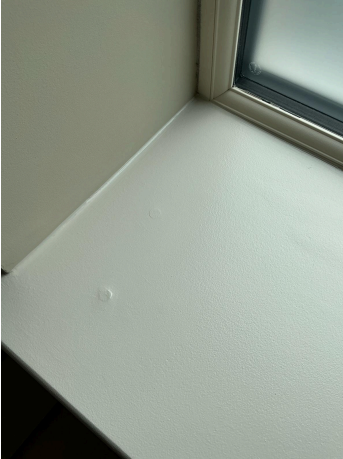
| 84 | | <ul style="list-style-type: none"> <li>- Nails popping through window board</li> </ul> |

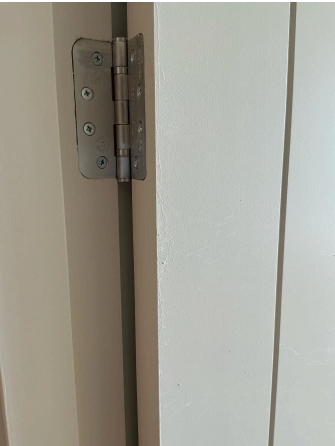
87

- Rough finish to edge of door

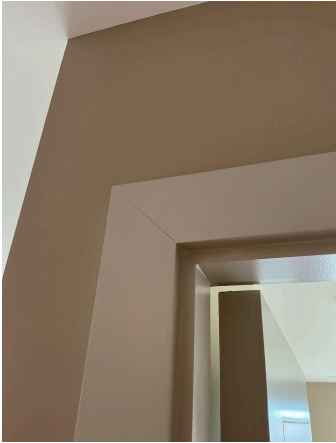
| 88 | | <ul style="list-style-type: none"> <li>- Exterior frame cracked in top left</li> </ul> |

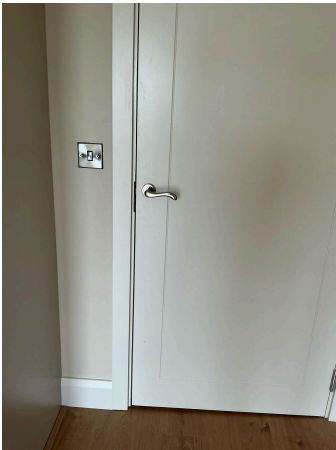
| 89 | | <ul style="list-style-type: none"> <li>- Drip marks on internal bottom left of door</li> <li>- Door rattling in frame</li> </ul> |

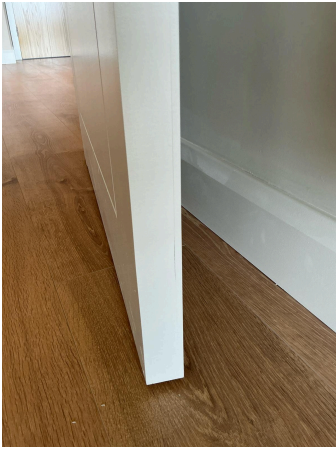
| 90 | | <ul style="list-style-type: none"> <li>- Bottom of door cracked</li> </ul> |

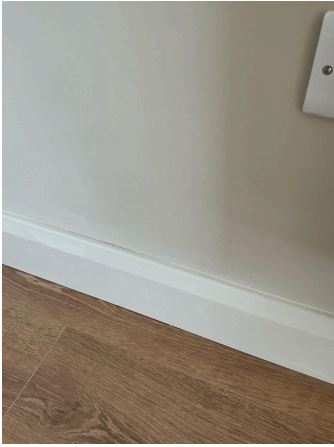
| 92 | | <ul style="list-style-type: none"> <li>- Reseal skirting to wall to the left of the radiator</li> <li>- Touch up paint in this area</li> </ul> |

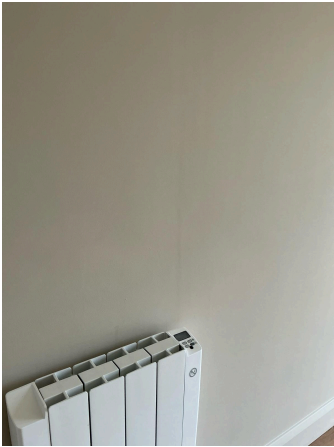
| 93 | | <ul style="list-style-type: none"> <li>- Ridge in wall above top right corner of radiator</li> <li>- Touch up paint above radiator</li> </ul> |

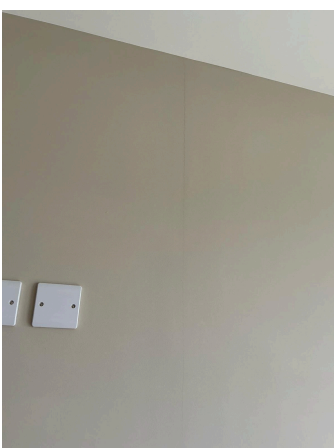
| 94 | | <ul style="list-style-type: none"> <li>- Crack along full height of wall to the right side of data sockets</li> </ul> |

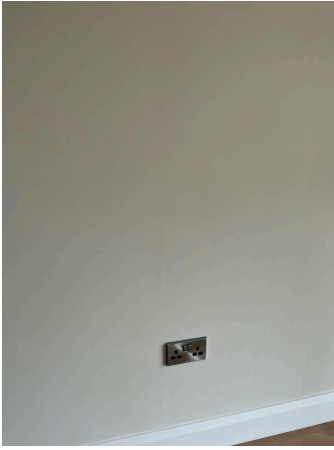
| 95 | | <ul style="list-style-type: none"> <li>- Crack along full height of wall to the left of low double socket and high double socket</li> </ul> |

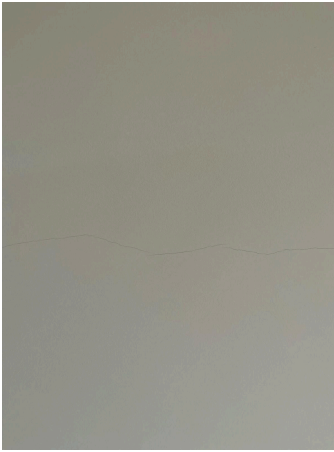
| 96 | | <ul style="list-style-type: none"> <li>- Horizontal crack half way up the left side wall between the high sockets and the far internal corner</li> </ul> |

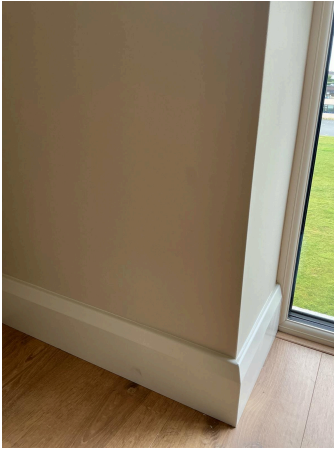
| 97 | | <ul style="list-style-type: none"> <li>- Skirting marked towards left side external corner</li> <li>- Wall marked 300mm up from the skirting</li> </ul> |

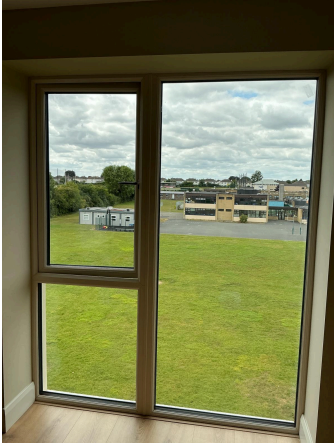
| 98 | | <ul style="list-style-type: none"> <li>- Transition bar not glued to floor</li> <li>- Seal window frame to reveals</li> <li>- Screw cap damaged on window handle</li> </ul> |

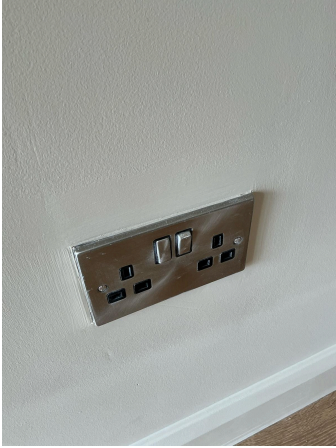
| 103 | | <ul style="list-style-type: none"> <li>- Clean double sockets on party wall</li> <li>- Scratch in wall at skirting level 600mm to left of the right side double socket</li> </ul> |
