**FineLine**  
- SNAGGING -

## Snag List Report

**Date of Inspection**  
01/08/2026

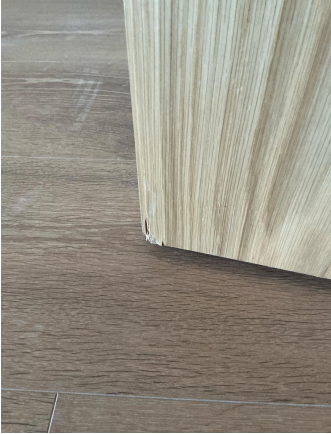
| 4 | | <ul style="list-style-type: none"><li>- Front door chipped in bottom corner</li></ul> |

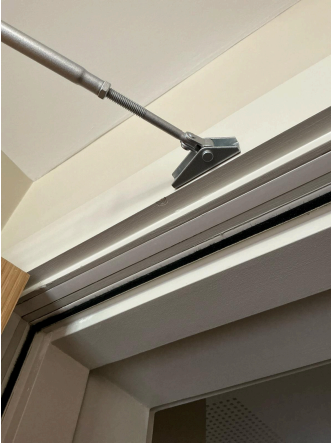
| 5 | | <ul style="list-style-type: none"><li>- Frame dented / chipped near self closer</li></ul> |

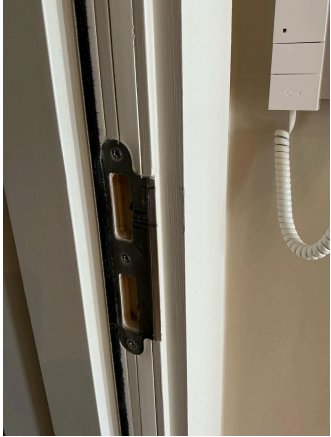
| 6 | | <ul style="list-style-type: none"><li>- Touch up paint near door receiver</li></ul> |

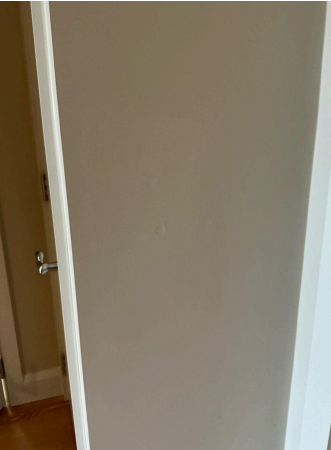
| 7 | | <ul style="list-style-type: none"><li>- Multiple dents in plaster on left wall of front door</li><li>- Beading showing through at top left of the same wall</li></ul> |

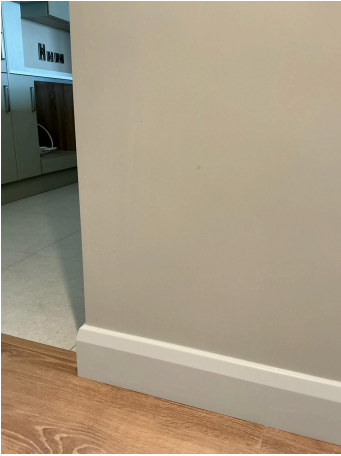
| 8 | | <ul style="list-style-type: none"><li>- Rough finish and marks to wall on the right side of kitchen entryway</li></ul> |

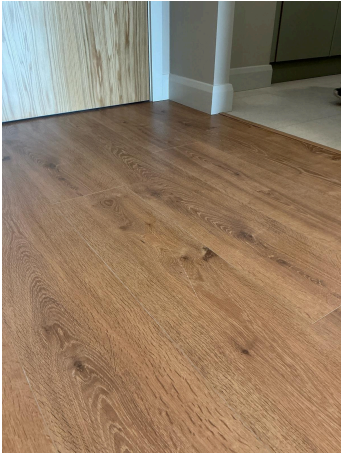
| 9 | | <ul style="list-style-type: none"><li>- Scratch in floor outside kitchen</li></ul> |

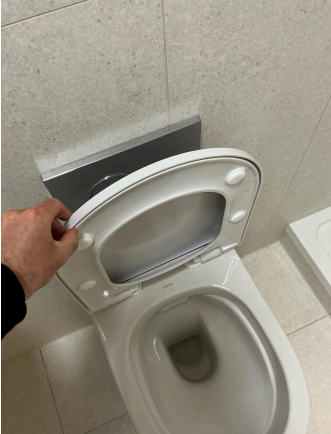
| 12 | | <ul style="list-style-type: none"><li>- Flush panel not accessible unless toilet lid is closed</li><li>- Toilet bowl stained and marked - clean and sanitize all sanitary ware</li><li>- Flush panel loose on wall</li></ul> |

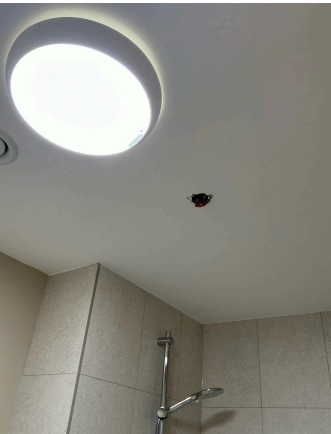
| 13 | | <ul style="list-style-type: none"><li>- Complete works on ceiling</li><li>- Debris in light unit</li></ul> |

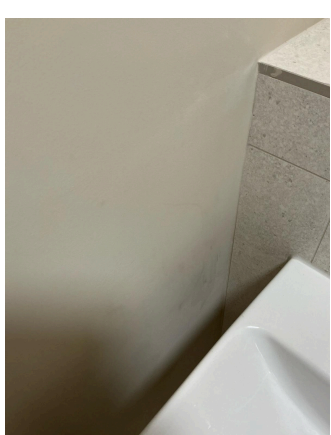
| 14 | | <ul style="list-style-type: none"><li>- Wall marked and dirty left of wash hand basin (<b>WHB</b>)</li></ul> |

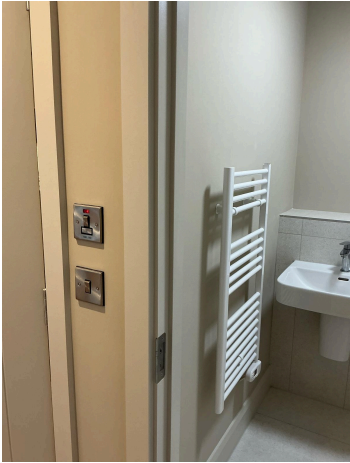
| - | | <ul style="list-style-type: none"> <li>- Towel radiator was operational and heating at the time of inspection</li> </ul> |

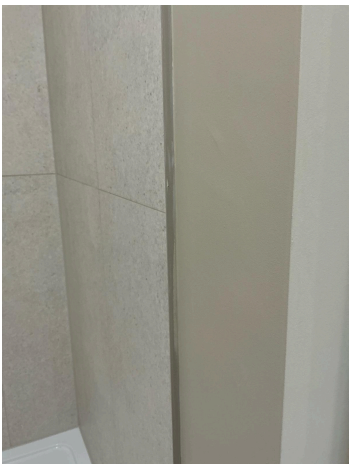
| 15 | | <ul style="list-style-type: none"> <li>- Tile trim marked on right side of shower and left corner above WHB</li> </ul> |

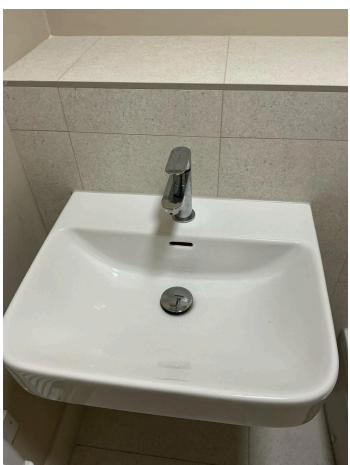
| - | | <ul style="list-style-type: none"> <li>- Sink operating OK</li> <li>- Water pressure OK</li> </ul> |

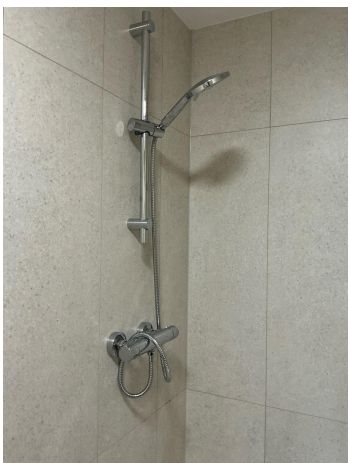
| - | | <ul style="list-style-type: none"> <li>- Shower operating OK</li> <li>- Water pressure OK</li> </ul> |

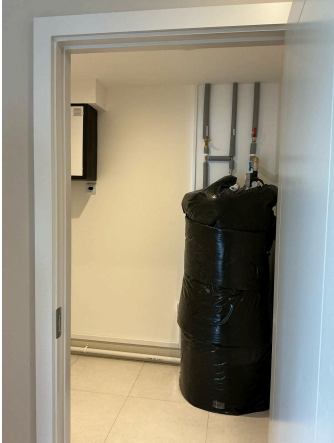
| - | | <ul style="list-style-type: none"><li>- Overall the utility room was completed to an excellent standard</li></ul> |

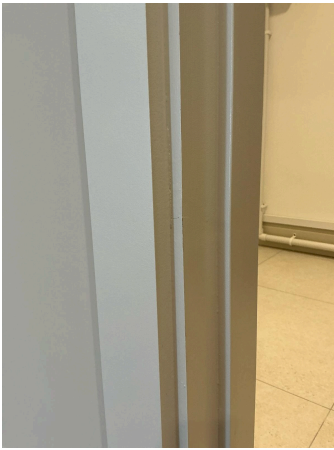
| 16 | | <ul style="list-style-type: none"><li>- Minor touch-ups needed around door frame</li></ul> |

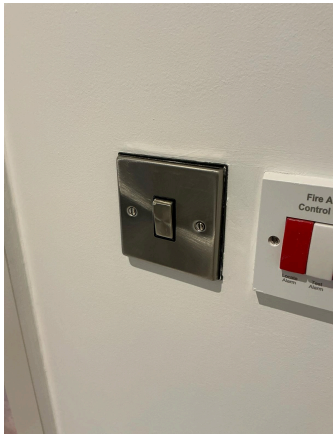
| 17 | | <ul style="list-style-type: none"><li>- Remove paint marks from switches, sockets and Eir boxes in top right corner of the wall with the fuseboard</li></ul> |

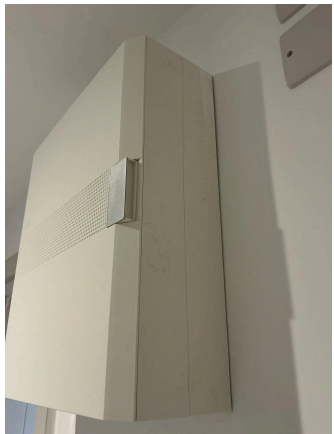
| 18 | | <ul style="list-style-type: none"><li>- Fuseboard dirty on all sides</li></ul> |

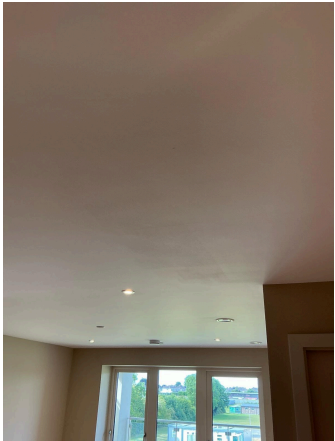
| 19 | | <ul style="list-style-type: none"><li>- Unfinished paint work flashing on ceiling - second coat needed</li></ul> |

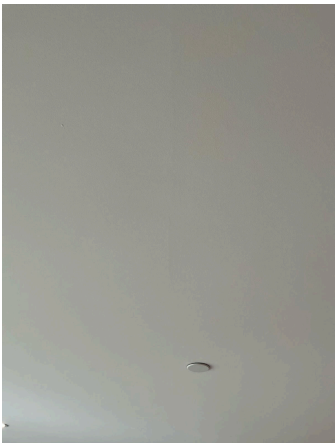
| 20 | | <ul style="list-style-type: none"><li>- Ridge running across full ceiling between the two rows of spotlights</li></ul> |

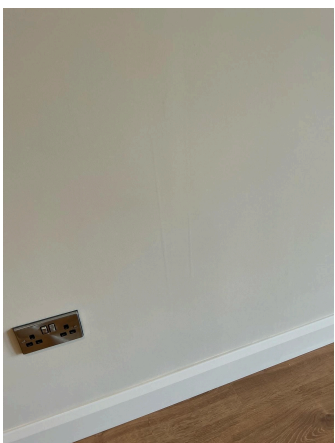
| 21 | | <ul style="list-style-type: none"><li>- Rough finish to plaster near double socket on left hand side wall</li></ul> |

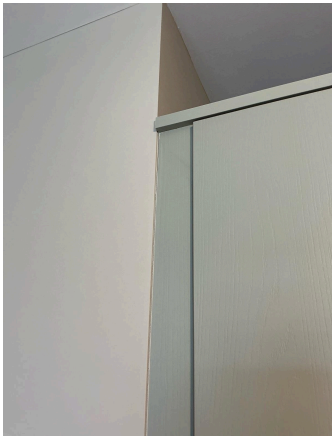
| 29 | | <ul style="list-style-type: none"><li>- Reseal top left of fridge-freezer frame</li><li>- White marks on bottom half of frame</li></ul> |

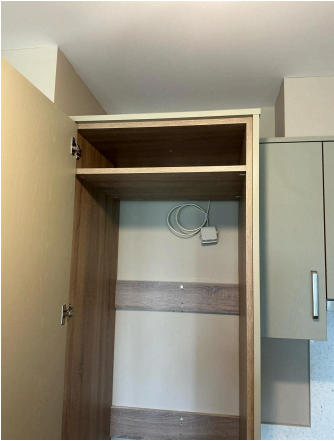
| 30 | | <ul style="list-style-type: none"><li>- Remove sticker from the top shelf</li><li>- Dust debris on the back wooden boards</li><li>- Black mark on wall behind freezer area</li></ul> |

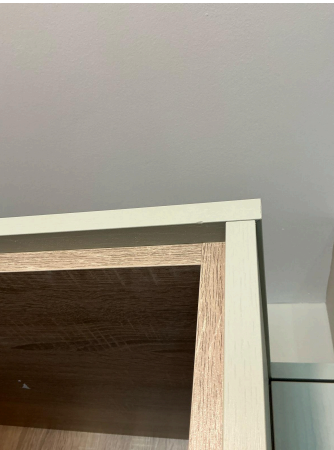
| 31 | | <ul style="list-style-type: none"><li>- Small dent at top of frame</li></ul> |

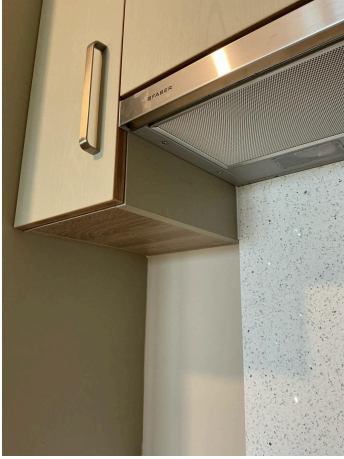
| 32 | | <ul style="list-style-type: none"> <li>- Remove sticker residue from cabinet on both sides under extractor</li> <li>- Reseal between fridge-freezer frame and back wall under hanging cabinet</li> <li>- Top cabinet to be cleaned of debris - check all cabinets</li> </ul> |

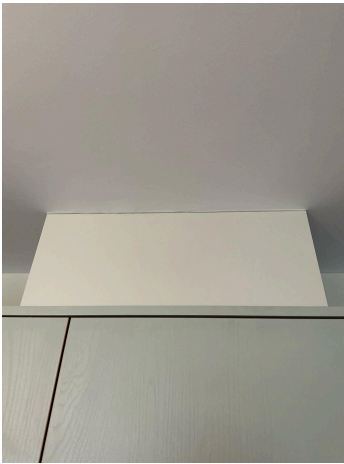
| 33 | | <ul style="list-style-type: none"> <li>- Reseal box above extractor and touch up same</li> </ul> |

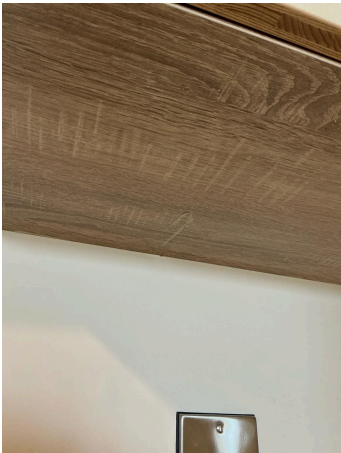
| 34 | | <ul style="list-style-type: none"> <li>- Remove tape from under hanging cabinet to the right of the extractor</li> </ul> |

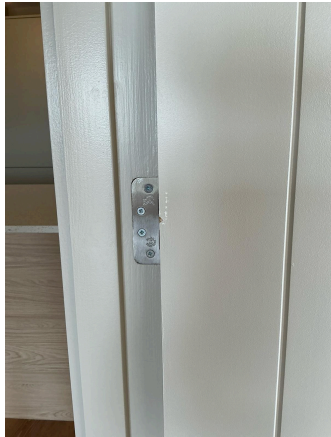
| 51 | | <ul style="list-style-type: none"><li>- Door chipped and marked along full left side</li><li>- Sticker hanging on underside of door near hinges</li><li>- Door rattling in frame</li></ul> |

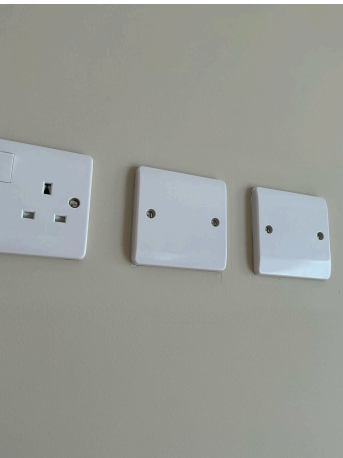
| 60 | | <ul style="list-style-type: none"> <li>- Tidy up finish around high data sockets and double socket</li> </ul> |

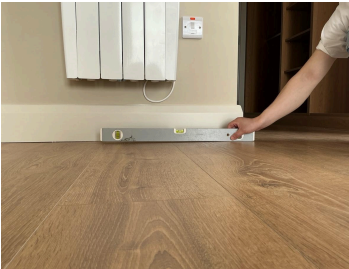
| Nr. | Location | Item | Why it's flagged |
|---|---|---|---|
| 64 | Master Bedroom | Considerable level difference in floor at wardrobe entryway | Structural / sub-floor - developer to confirm remedy |

| 64 | | <ul style="list-style-type: none"> <li>- <b>Priority</b></li> <li>- Considerable level difference in floor at wardrobe entryway</li> <li>- Builder to confirm possible solutions with client</li> </ul> |

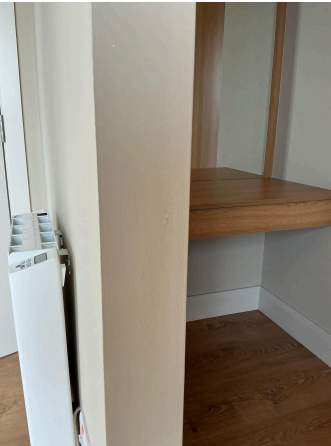
| 65 | | <ul style="list-style-type: none"><li>- Rough finish to wall on entrance to wardrobe on the left side</li><li>- Touch up this full wall - uneven paint finish</li></ul> |

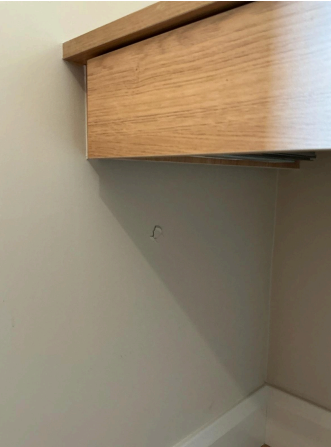
| 66 | | <ul style="list-style-type: none"><li>- Nail popped under mirror station</li></ul> |

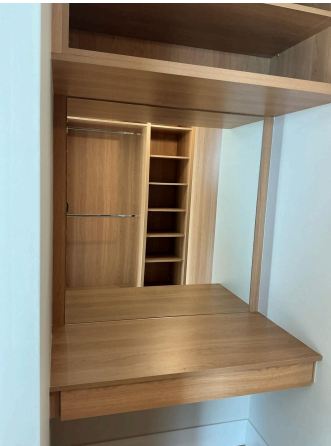
| 67 | | <ul style="list-style-type: none"><li>- Clean mirror and station, ensure no scratches</li><li>- Remove black mark from pull out drawer in the middle</li><li>- Minor chip to right corner of pull out drawer</li></ul> |

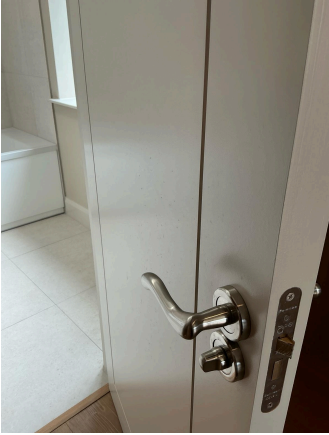
| 72 | | - Door stained / marked with splashes, touch up and ensure uniform paint finish. |

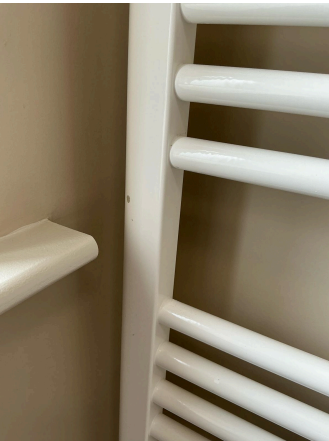
| 73 | | - Radiator marked and has paint splashes / debris |

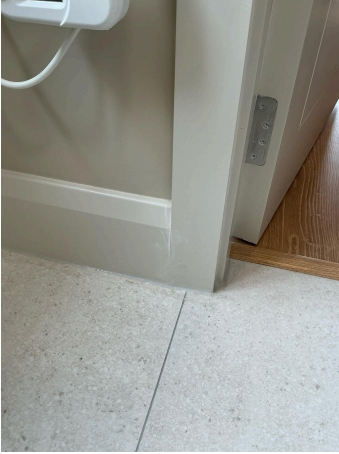
| 74 | | <ul style="list-style-type: none"> <li>- Touch up skirting at bottom left of door frame</li> </ul> |

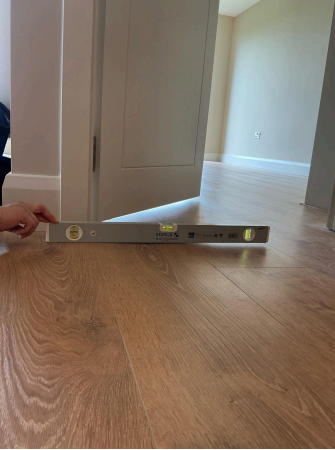
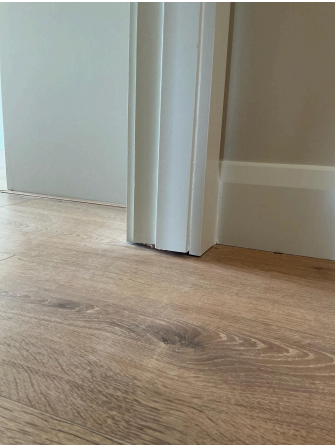
85

- **Priority**
- Considerable level difference in floor of bedroom to hallway
- Builder to confirm possible solutions with client

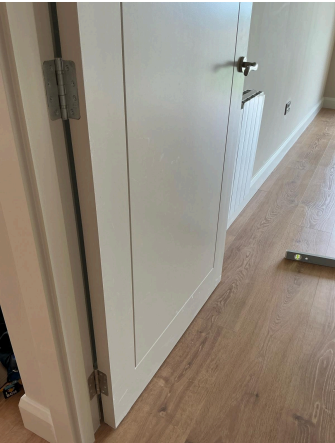
86

- Marks flashing on entire door

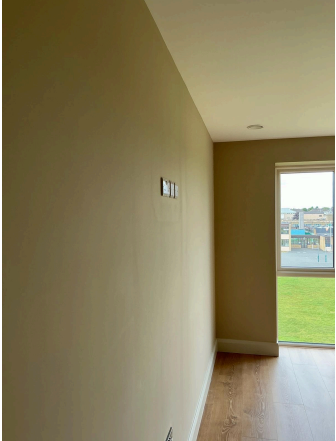
| 91 | | <ul style="list-style-type: none"> <li>- Uneven finish to left side wall - touch up and ensure uniform finish</li> </ul> |

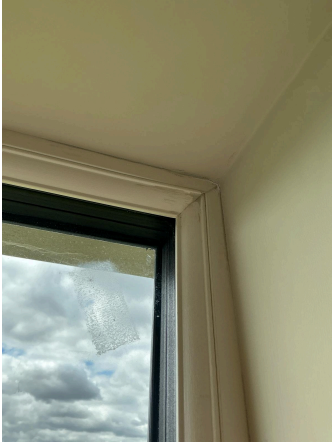
| 99 | | <ul style="list-style-type: none"> <li>- Remove residue from window</li> <li>- Remove paint marks from the corner of frame - check full frame for marks / damage</li> </ul> |

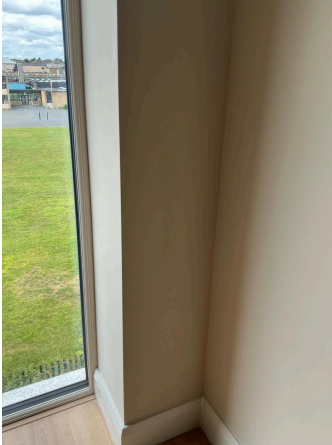
| 100 | | <ul style="list-style-type: none"> <li>- Uneven paint finish on wall to the right of the window</li> </ul> |

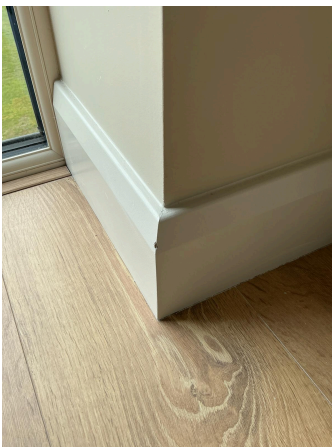
| 101 | | <ul style="list-style-type: none"> <li>- Skirting damaged at corner on right external corner of window</li> </ul> |

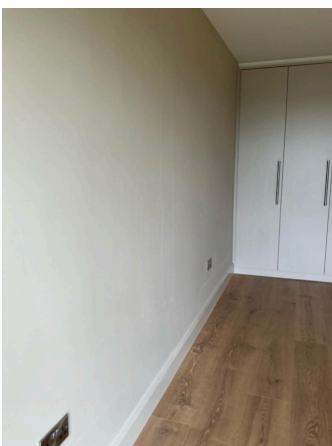
| 102 | | <ul style="list-style-type: none"> <li>- Very uneven / unfinished paint work on the party wall - repaint full wall</li> </ul> |

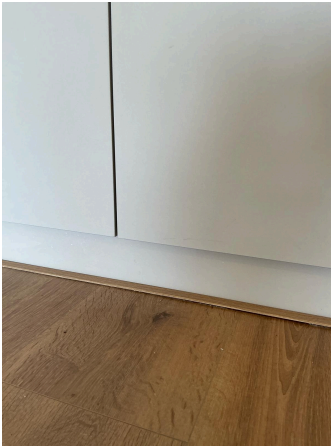
| 104 | | <ul style="list-style-type: none"> <li>- Bottom panel and doors of wardrobe marked / dirty</li> <li>- Full clean to wardrobe - doors, handles, rails, shelves</li> <li>- Transition bar not glued to floor</li> </ul> |

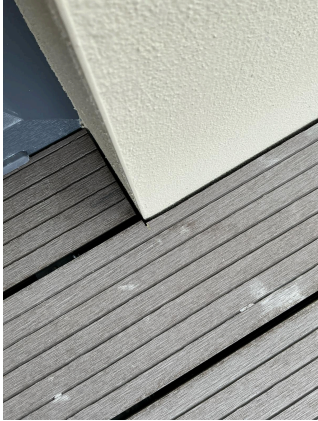
- Flooring overcut on *Balcony*

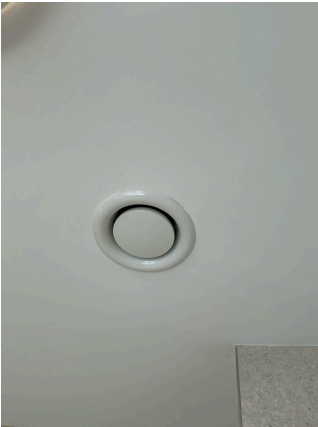
- Gap in the vent seal to the ceiling in *En Suite*

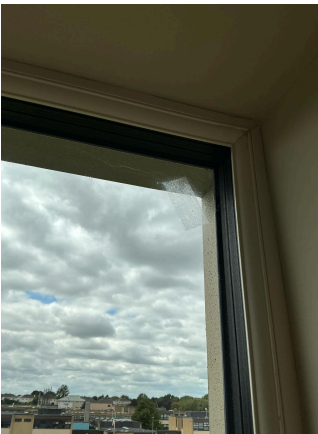
- Considerable amount of residue on the windows, particularly in the bedrooms

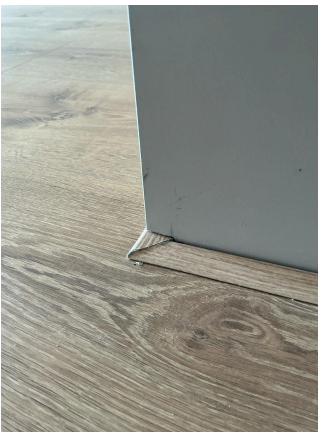
- Damage to bottom of wardrobe in *Bedroom 2*
- Transition bars not flush at joining
